***EXPERIENCE IN EFFECTIVE APPLICATION OF METALLIC
MATERIALS FOR CONSTRUCTION OF FGD SYSTEMS***

L. E. Shoemaker and J. R. Crum
Special Metals Corporation
3200 Riverside Drive
Huntington, WV 25705
USA

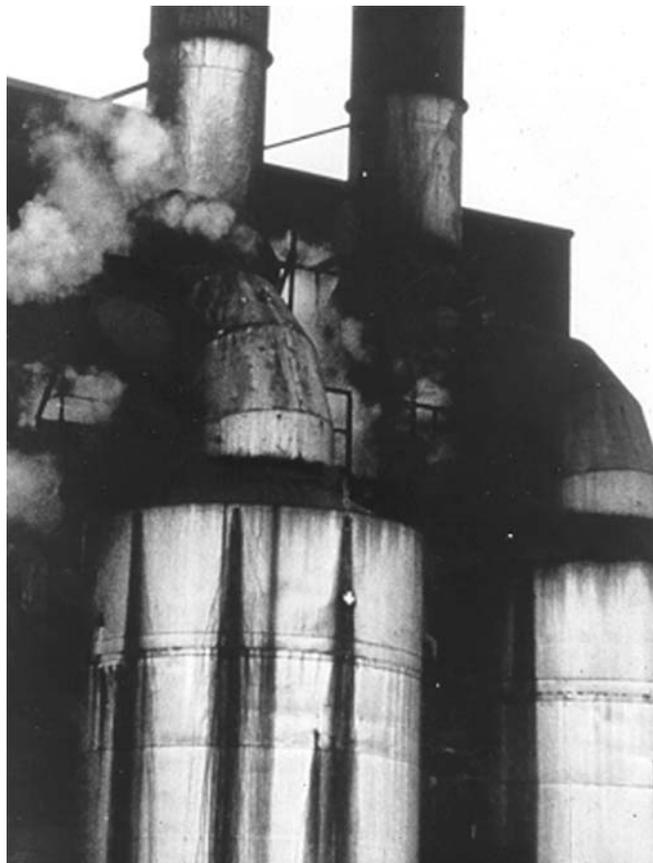
FIGURE 1 – FGD absorber vessel leaking due to non-metallic lining

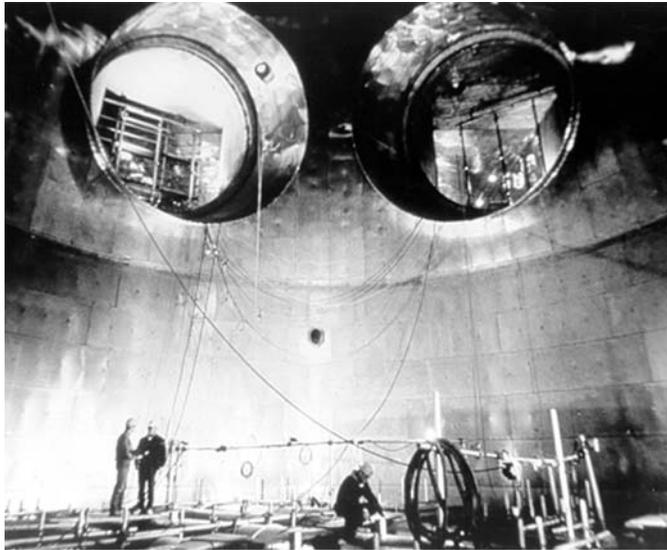
FIGURE 2 – Alloy C-276 sheet lined absorber vessel using the “wallpaper” technique

As stated earlier, the conditions inside the absorber vessel (Figure 2) tend to reach equilibrium as the flue gases mix with the limestone slurry. The conditions are cooler (typically 130 to 160°F/ 54°C to 71°C) and the pH is higher (typically 4.0 to 5.5). Newer absorbers are often designed so that the walls are continuously washed by the slurry to avoid formation of deposits which can induce crevice corrosion.

Alloy C-276 is considered the “workhorse” alloy of the FGD industry. This product is widely used in the more corrosive areas of FGD systems. In the form of wallpaper or alloy clad steel plate, alloy C-276 is used for absorber vessel wall construction and construction of outlet ducts. Because of the mechanical rigors of their environment, floors are normally solid alloy plate. Alloy C-276 clad steel plate is commonly used for construction of FGD chimney flues. The alloy has offered excellent performance in all these applications.

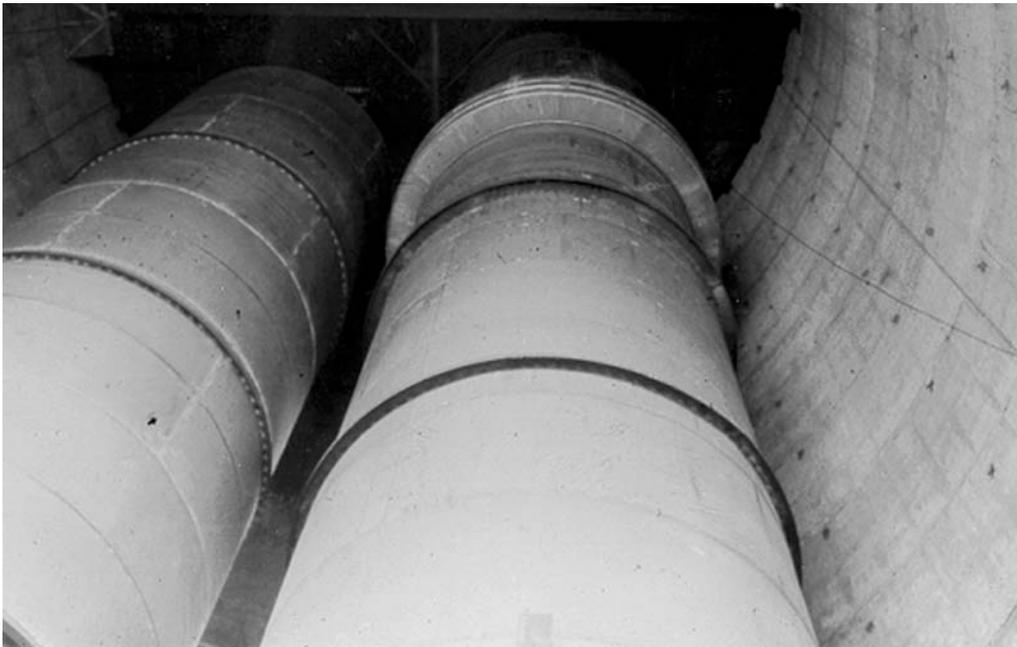
FIGURE 3 - Chimney flues fabricated from solid alloy 625 plate

The chimney flues (Figures 3 and 4) carry the moist, scrubbed gases from the system and emit it into the atmosphere. The chimneys are necessarily tall in order to achieve sufficient draft to carry the gases from the system and emit them into the atmosphere where they will be dispersed from the immediate area surrounding the power plant. While the exterior of the chimney is normally concrete, the flue is often metallic. Alloy clad steel flues are quite popular and have given long, reliable service. The storm cap (the top of the chimney flue that prevents atmospheric moisture from getting into the flue) is normally alloy plate. The flue drainage system (normally gutters which collect condensate that forms on the chimney flue walls) is often fabricated from light alloy plate and sheet.

The chimney flues seen in Figures 3 and 4 were fabricated from roll-bonded alloy clad steel plate. This mode of construction is accomplished at about half the cost of solid alloy plate construction. Low cost carbon steel provides the structural strength requirements while a thin cladding of alloy provides corrosion protection.

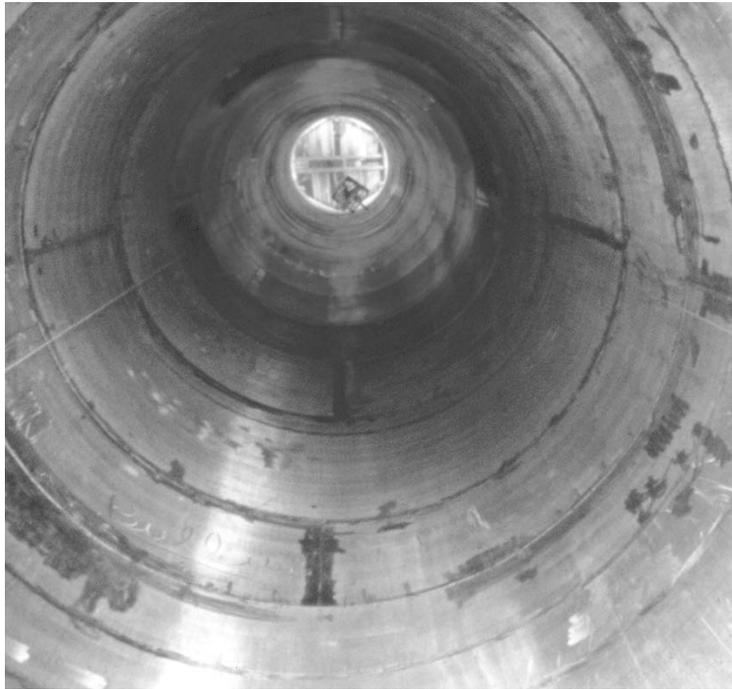
FIGURE 4 – FGD chimney flue fabricated from alloy C-276 clad steel plate

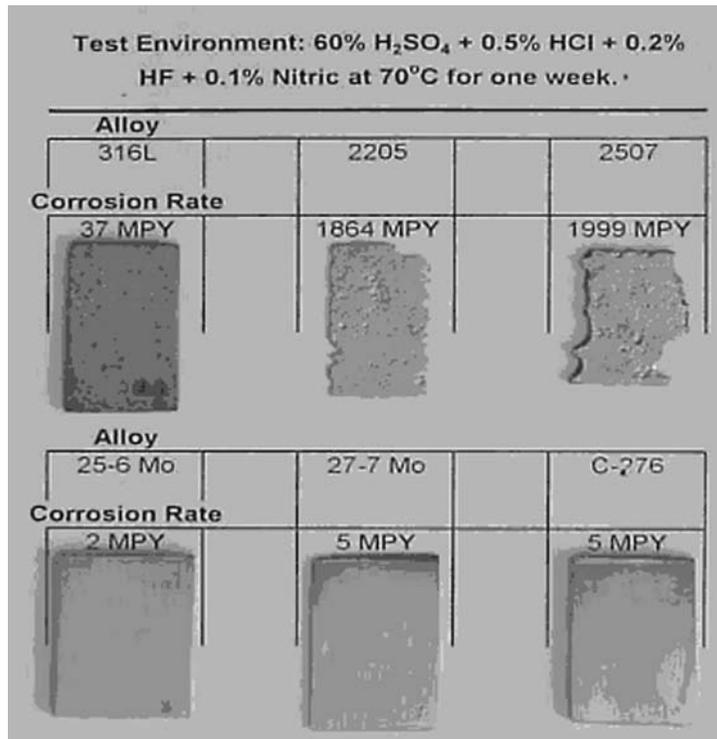
FIGURE 5 – Corrosion of various alloys in a simulated FGD environment.

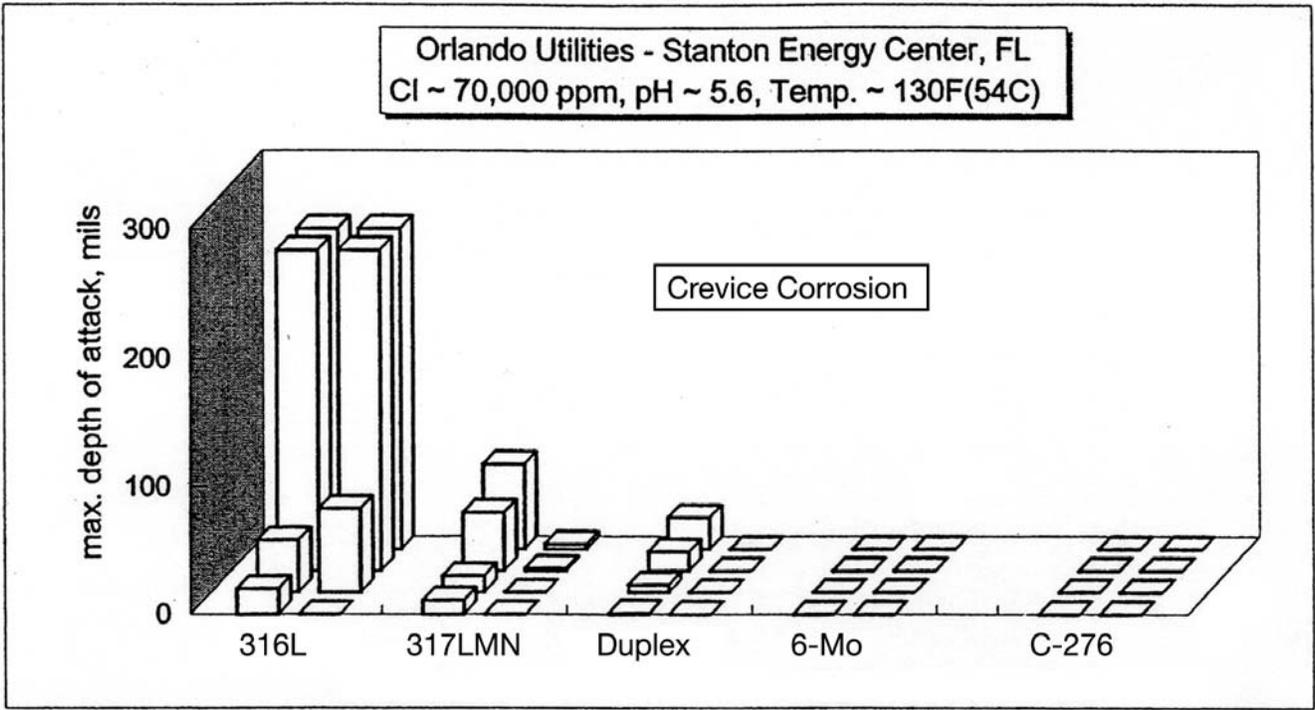
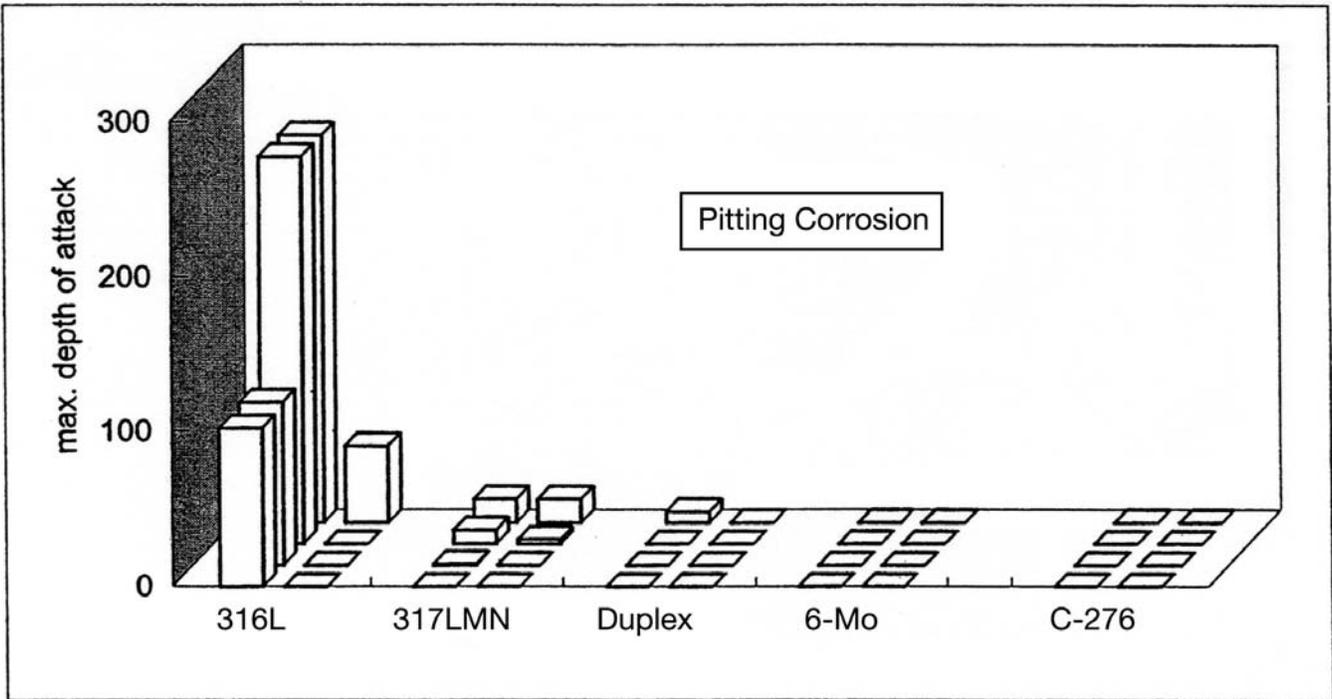
FIGURE 6 – Maximum depth of crevice corrosion and bold surface pitting. For each alloy, the 1st set of columns (going from front to back) represent data for replicate specimens with tight crevice formers and the 2nd set for those with loose crevice formers. The exposure duration for all specimens in this scrubber was 270 days. The tallest 4 bars for crevice corrosion and the tallest 2 for pitting correspond to specimen perforation by corrosion. (1mil = 0.0254 mm).

A study sponsored by the Nickel Development Institute⁶ compared several alloys in FGD service. In this study (Figure 6), duplex alloy 2205 (UNS S31803) was found to be more resistant than the 300 series stainless steels but not nearly as resistant as the 6% molybdenum super-austenitic stainless steel (UNS N08926) or the higher nickel alloy C-276 (UNS N10276). These results correlate well with laboratory tests in which duplex stainless steels are shown to be less resistant to localized corrosion than 6 or 7 % molybdenum and higher nickel alloys (Figure 7).

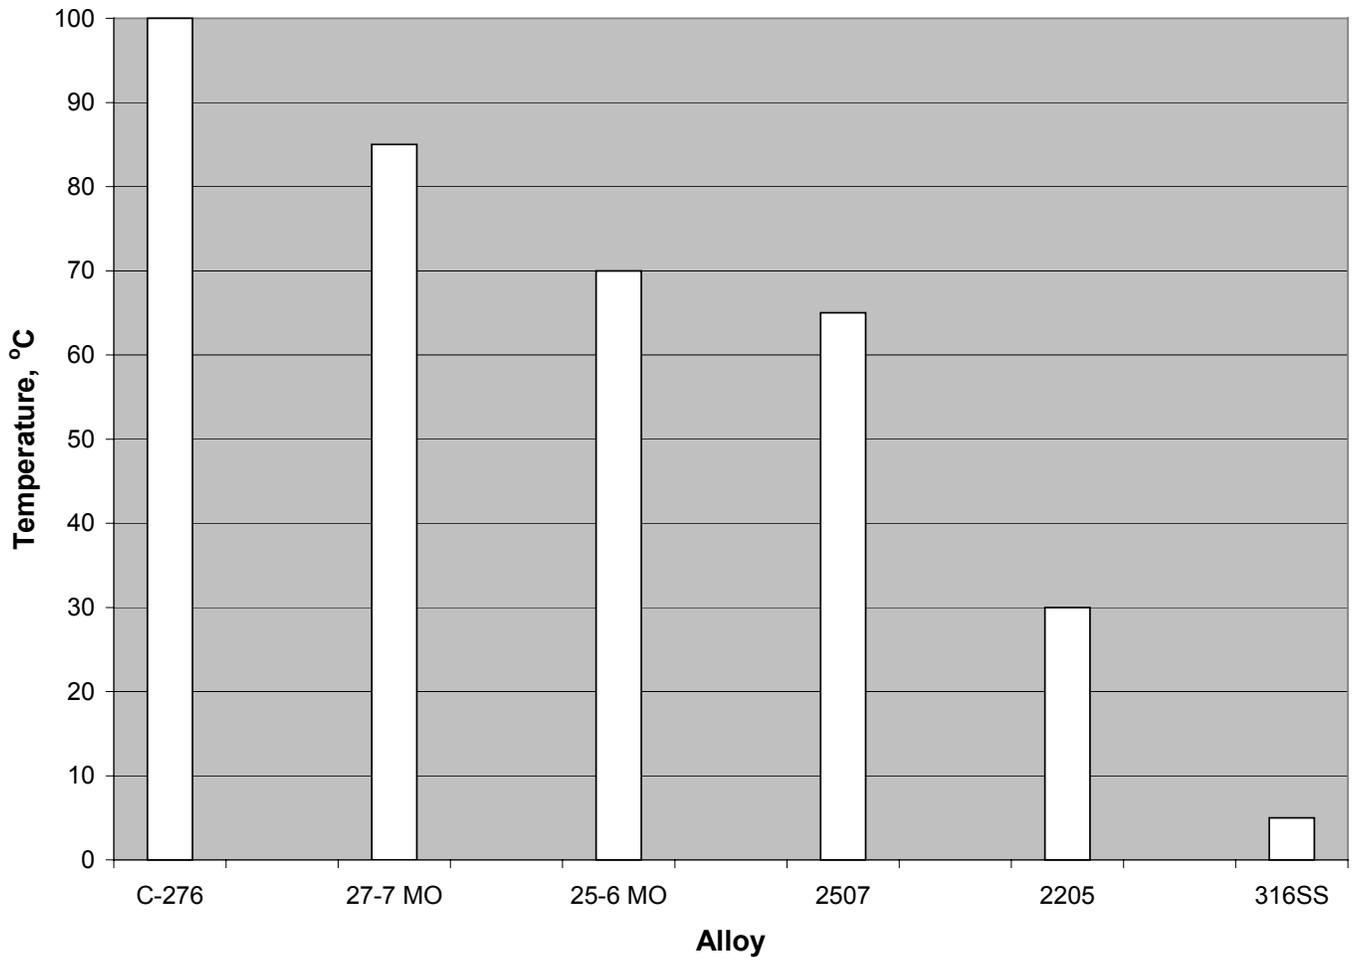
FIGURE 7 – CPT of Several FGD alloys in Green Death

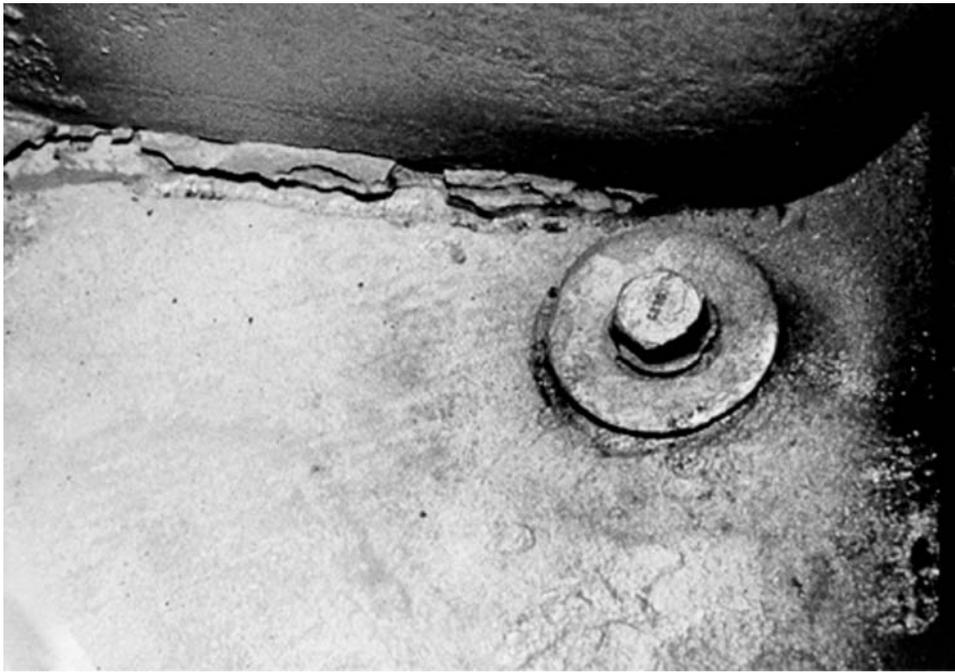
FIGURE 8 – Corroded alloy C-276 weldment in FGD bypass duct

The superiority of the corrosion resistance of alloy 686 to alloy C-276 is demonstrated in Figures 8 and 9. The alloy C-276 by-pass duct at Seminole Electric Cooperative's Palatka Station was corroding rapidly to the point that the weld had lost essentially all structural integrity (Figure 8). The filler metal C-276 weldment was replaced with one deposited with filler metal 686CPT®, the alloy 686 welding product (AWS A5.14 ERNiCrMo-14). After 6 more months of service, the alloy 686 weldment showed full resistance to the environment while the alloy C-276 ducting continues to corrode (Figure 9). To better understand this environment, a test panel made up of plate samples of alloys 25-6MO, C-276, 22, and 686 was installed on the floor of the duct beneath the level of the corrosive condensate. After 6 months of exposure, the alloy 686 panel was untouched, incipient corrosion was found on the alloy 22 and C-276 samples, while the alloy 25-6MO sample was completely corroded away (Figure 10). Eventually, the alloy C-276 duct walls and floor were replaced with alloy 686 and the corrosion stopped.

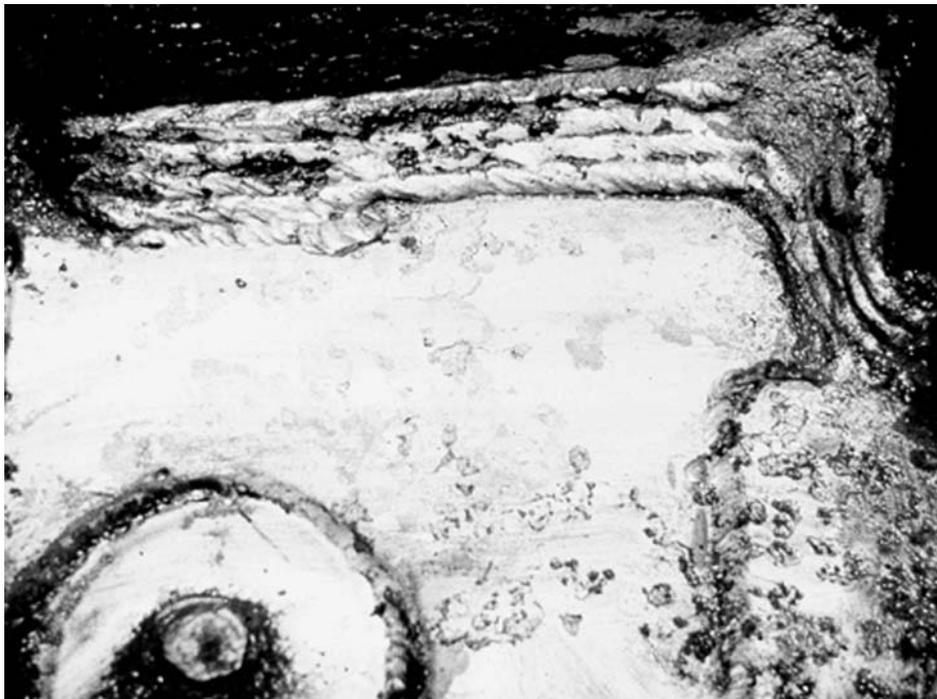
FIGURE 9 – Alloy 686 weldment after 6 month exposure in FGD Bypass Duct

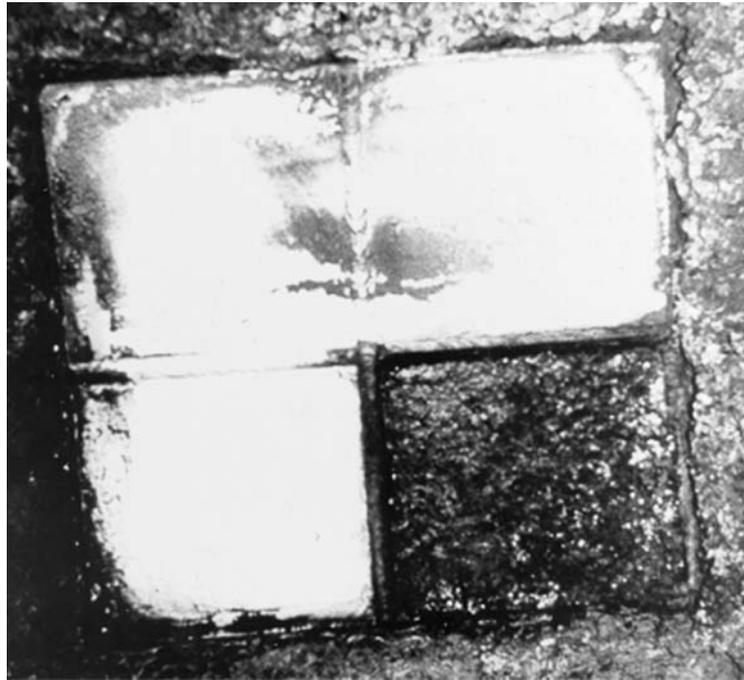
FIGURE 10 – Four alloy test panel in FGD bypass duct after 6 month exposure

In attempting to cut costs, designers sometimes are tempted to use a heavier section of a low alloy as opposed to a higher, more resistant alloy. The experience learned from the test sample at the Palatka Station demonstrates why this is not a good idea. In this case a ¼” (6.2mm) section of a lesser alloy (a super-austenitic stainless steel, alloy 25-6MO) corroded away in 6 months while the higher alloyed 686 sample was not corroded at all. Thus, a thin section (1/16” / 1.6mm) of alloy 686 would have a long life while a heavier section of a lower alloyed material would fail in 6 months or less. And when one compares the cost of 1/16” (1.6mm) alloy 686 lining with that of ¼” (6.2mm) alloy 25-6MO plate, the alloy 686 construction is actually lower in total (material + construction) cost. So, it is recommended that alloy clad steel plate construction or “wallpaper” lining with thin alloy sheet be considered for FGD construction when very aggressive environments are anticipated.

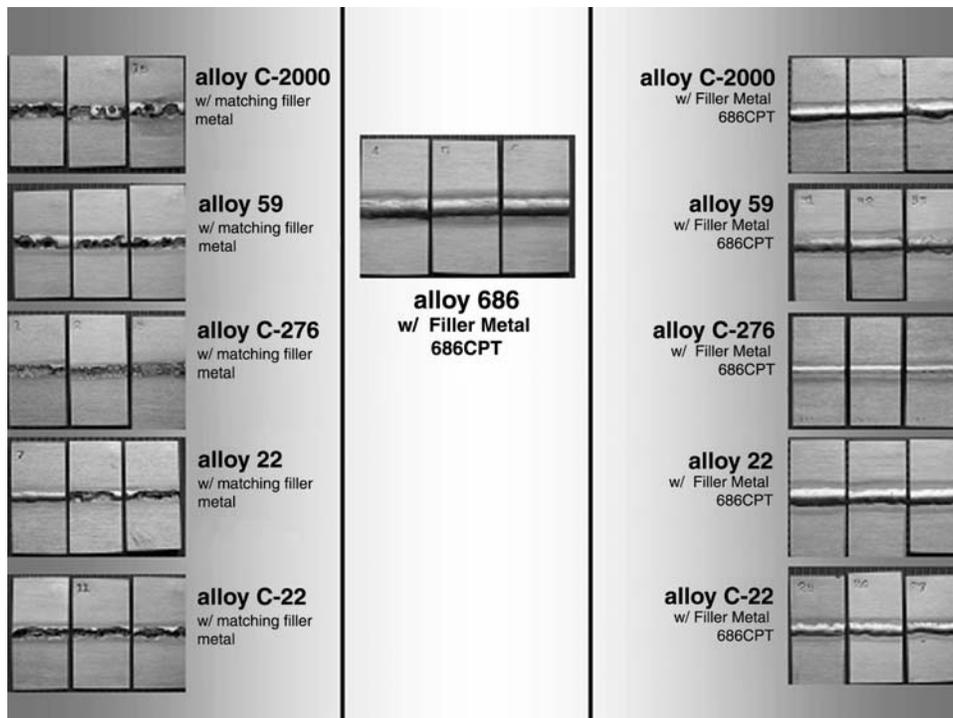
FIGURE 11 – The advantage of using overmatching over matching composition welding products for joining corrosion-resistant alloys. Samples exposed in boiling (103°C) green death solution for 72 hours.

Alloy 686 welding products offer over-matching chemical composition for all FGD alloys (except alloy 686 itself) and, thus, are recommended for this purpose (Figure 11). They are also recommended for joining alloy clad steel plate.

It is a well known fact that nickel-chromium-molybdenum weldments are subject to elemental segregation during solidification. High melting elements solidify more quickly than those with lower melting temperatures so some parts of the weld cell are enriched with elements while the other end is depleted. This phenomenon results in weldments that despite the fact that they exhibit the same bulk chemical composition as the wrought base metal are found to be less resistant to corrosion. To offset this effect, welding products that are more highly alloyed than the base metal are preferred. This again is demonstrated by the experience at the Palatka utility. The alloy C-276 weldment was corroding at a greater rate than the wrought alloy C-276 base metal to the extent that the weld integrity was compromised while the alloy plate duct was still serviceable. The alloy 686 replacement weldments, however, offered full resistance to the environment. Figure 11 provides further evidence of this. Matching composition welds tested in the Green Death solution exhibit severe corrosion while over-matching composition filler metal 686CPT welds are not attacked.

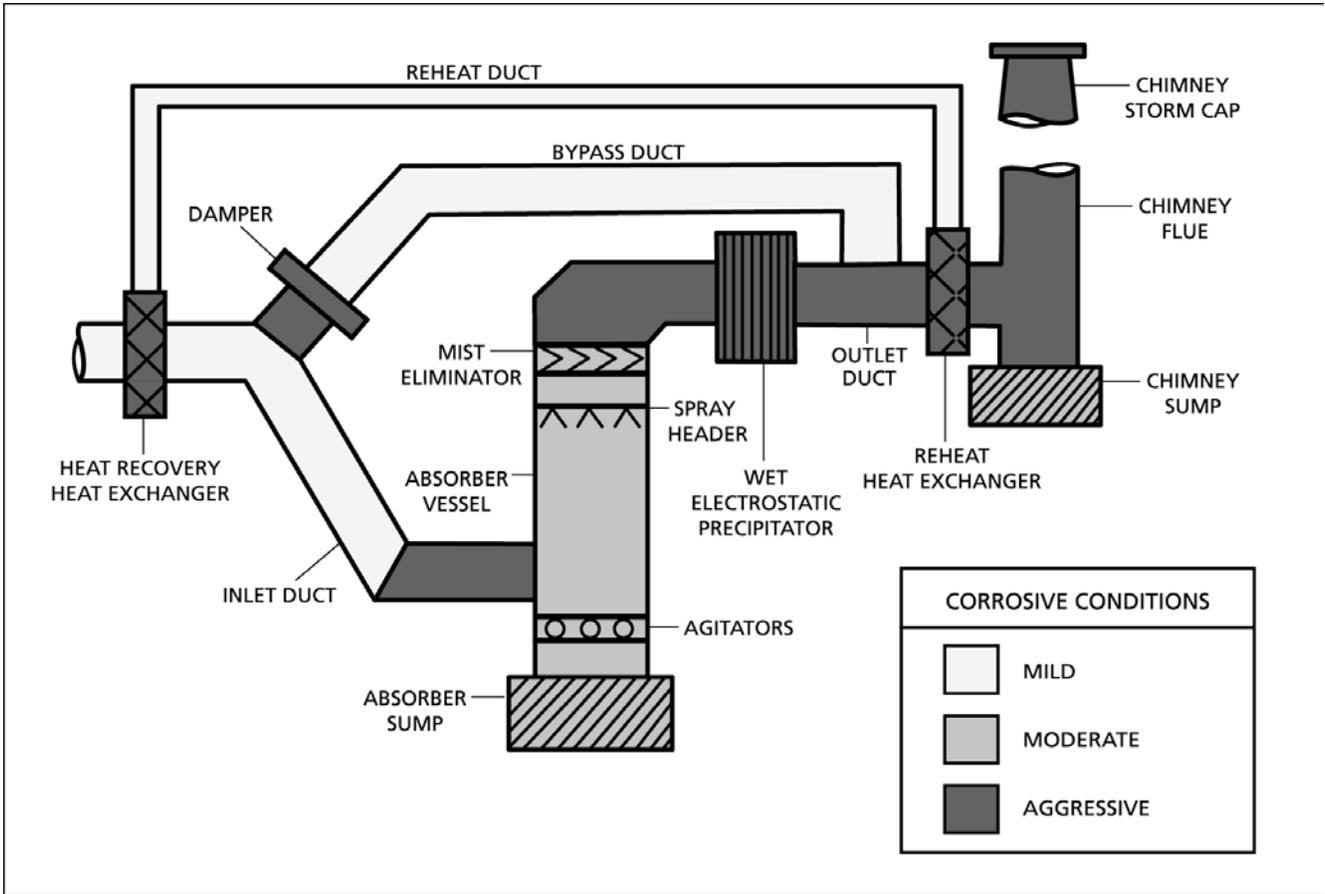
FIGURE 12 – Corrosive conditions in the wet limestone FGD system

All the components discussed are shown in the schematic diagram of an FGD system in Figure 12. Areas of varying corrosivity are color coded to represent mild (white), moderate (gray) and aggressive (black) conditions. In general, material selection for the mild conditions would be austenitic stainless steel and duplex alloys, the moderate conditions would best be handled by 6 or 7 % molybdenum super austenitic stainless steels and the aggressive conditions would require much more highly alloyed Ni-Cr-Mo-W materials.
